7

Wake Robin Sugarbush

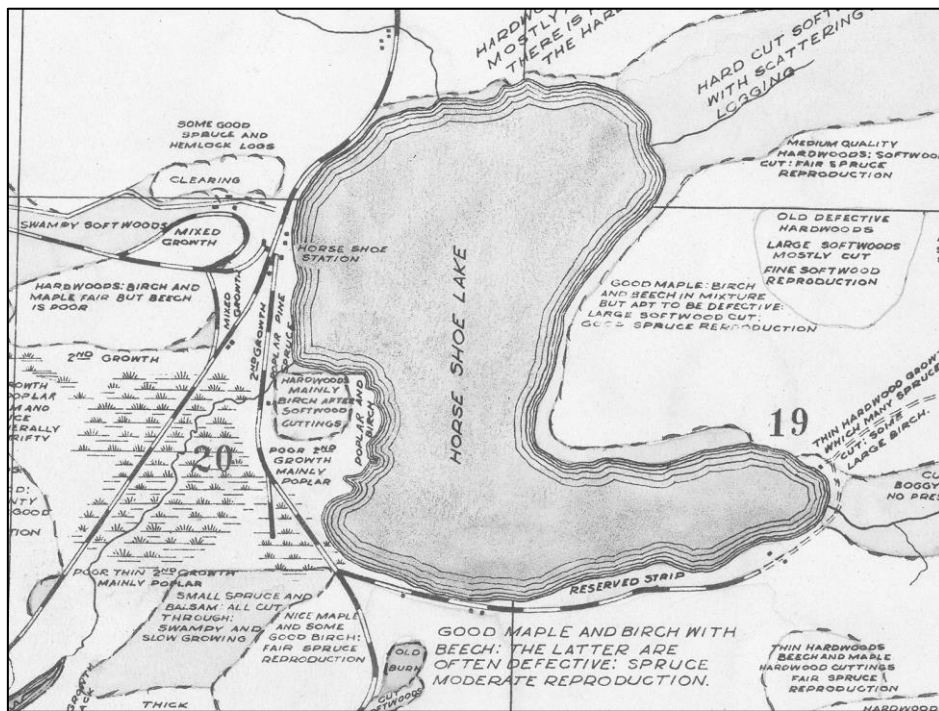
Figure 7.1: Excerpt from Connors and Sewell map of 1913 showing area around Horseshoe Lake. Note the Wake Robin Railroad along the south shore, terminating at two buildings at the southeast corner of the lake.

The Wake Robin sugarbush, and the associated Wake Robin Railroad were located along the south shore of Horseshoe Lake, with the sugar house and later syrup plant located at the far southeast corner of the lake (Figure 7.1). Some of the earliest maple sugaring activities at Horseshoe happened at the Wake Robin sugarbush, along with the Grasse River sugarbush. Lands located along the south shore of Horseshoe Lake where the Wake Robin sugarbush was established were purchased by A.A. Low on August 31, 1896 and September 1, 1896, were among the very earliest of Low's purchases at Horseshoe.¹

where the Wake Robin Railroad ended. Extending beyond the tracks and around the east side of the lake is a road connecting to Colonel Barbour's estate on Tupper Lake. (see Figure 7.1). The route of the Wake Robin Railroad and the road connecting the end of the railroad to Tupper Lake is the same path that is today covered by State Highway 421.

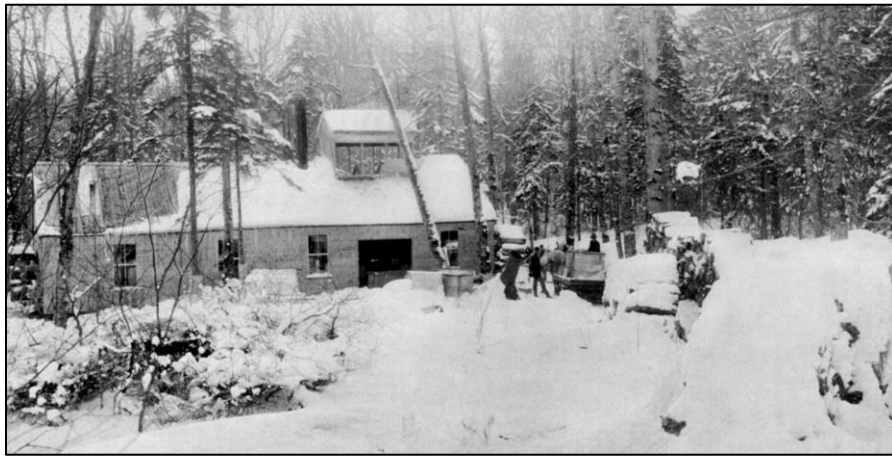
Figure 7.2: First Wake Robin Sugar House as depicted in 1898 *Annual Report of the Commissioners of Fisheries, Game and Forests for the State of New York*.

These three wintertime images (Figures 7.2 to 7.4) depict a simple wood frame sugarhouse with a cupola for venting steam and two smoke stacks, indicating the presence of two evaporators. There is no indication of a railroad grade nearby. Instead, the sugar house seems to be nestled in a small opening in the woods and was accessed by woods road and teams of horses pulling sleds and sleighs. A raised ramp made of large logs was built alongside the sugar house for horse teams pulling sap gathering tanks on sleds to unload and use gravity to drain their tanks into larger storage tanks in the sugar house. Near the front and along the side of the sugar house are stacks of firewood to feed the evaporators. These photos have not been attributed to any photographer, so we do not know who took these three images.

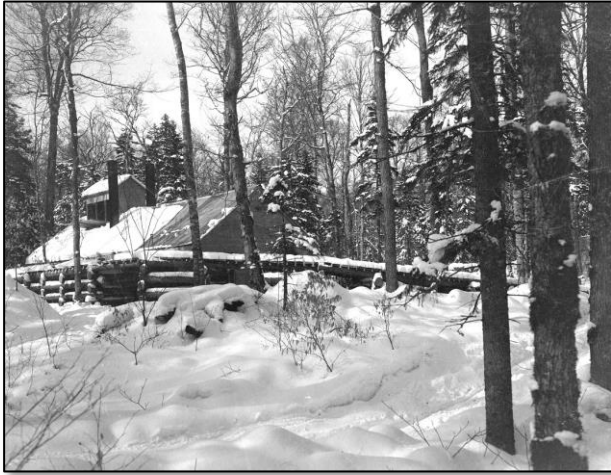
Figure 7.3: Photo of the Wake Robin sugar house, ca. 1898. Collections of the Piercefield Museum.

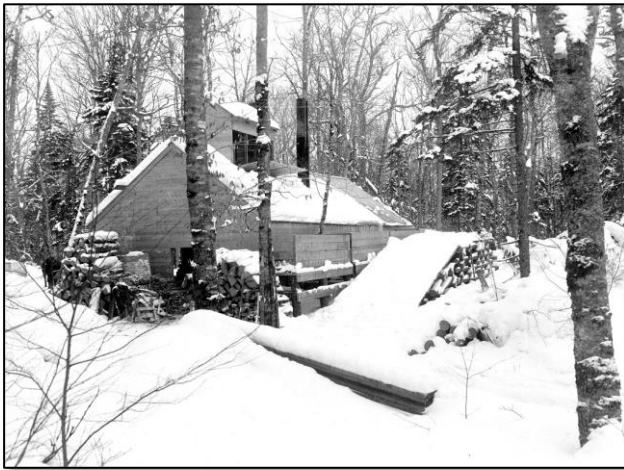
Figure 7.4: Opposite view of the Wake Robin sugar house, ca. 1898. Collections of the Piercefield Museum.

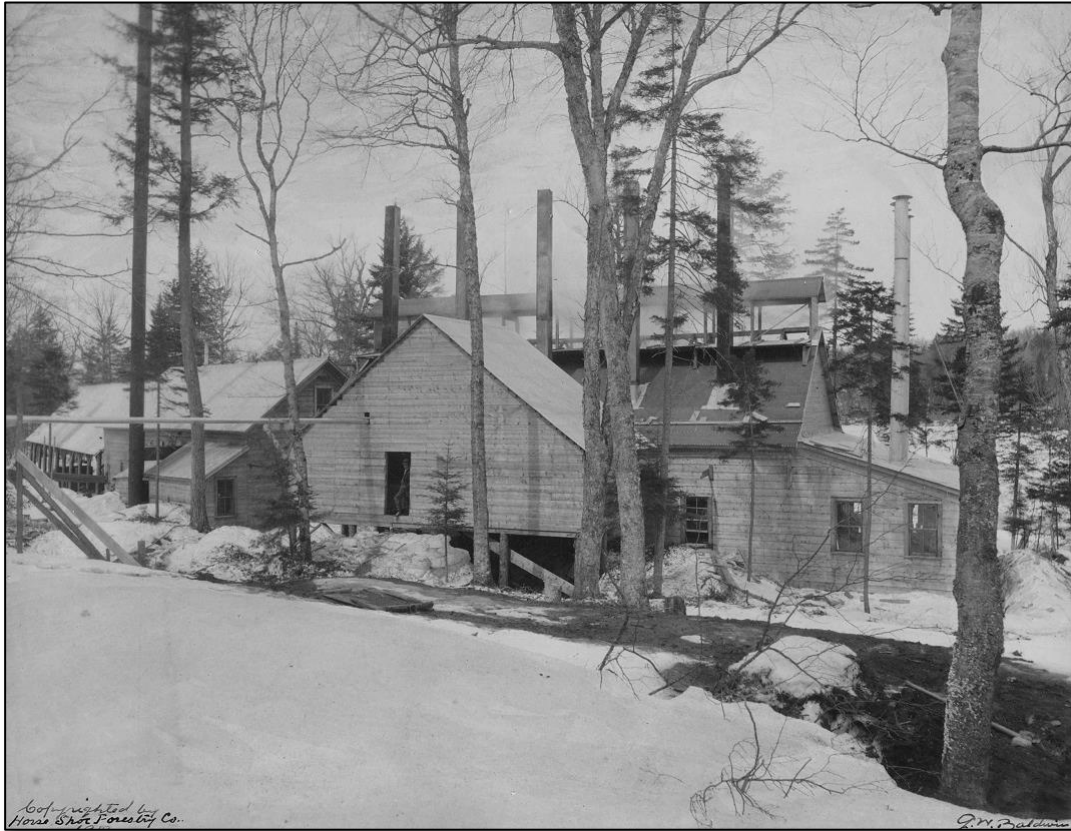
Figure 7.5: Baldwin image showing Wake Robin syrup plant, looking north. Not the lake and far shoreline in background. Collections of the Adirondack Experience P020992.

Baldwin's two photos of the Wake Robin syrup plant show a sprawling linear complex of interconnected buildings stretched out between the Wake Robin Railroad grade and the shore of Horseshoe Lake which can be seen in the background of Figure 7.5. The central feature in the images is the evaporation room, a large, one and a half-story rectangular gable ended structure with five very tall, square smoke stacks protruding from the roof and a cupola along the length of the ridgeline. These five stacks are indicative of this syrup plant housing five large dimension sap evaporators. All the structures in the Wake Robin syrup plant were wood framed and wood sided.

Along the east face of the evaporation room is a shed roof addition that housed the syrup finishing rig, as can be seen by the four tightly spaced round smoke stacks to the right of the photo in Figure 7.5. In the front of the evaporation room, upslope on the railroad side of the syrup plant, oriented perpendicular to the layout of the plant is a one story sap storage building. This building is leveled above sloping ground by a series of piers

and is elevated above the level of the evaporator building. The elevated design further permits the use of gravity to feed sap from the storage tanks to the nearby evaporators built at a slightly lower elevation. In both images we can see a sap delivery pipeline suspended above the ground and running directly into the outer wall of the sap storage building, carrying sap from collection points upslope in the sugarbush.

In the background of Figure 7.5, just over the roof of the syrup room one can clearly see that the syrup plant was built immediately adjacent to Horseshoe Lake. Additionally, in this photo, the far shoreline of the lakeshore does not appear to be particularly far away, consistent with the placement of the syrup plant at the narrow arm of the southeast corner of the lake. Unfortunately, we do not have any images showing the north side of the plant, closest to the water, so we are unable to conclusively describe design features or elements of construction that were built between the plant and the shoreline of Horseshoe Lake. Similarly, the snow in the images obscures the details of the foundation and footings of the various structures in the plant.

What is lacking is a poured concrete floor or foundations that would demarcate the outline of one or more buildings. In the case of the Wake Robin syrup plant, the builders created level buildings and compensated for building on the sloping land by raising all the structures above the ground on footings. Such a design can be seen in the photo in Figure 7.5 and is supported

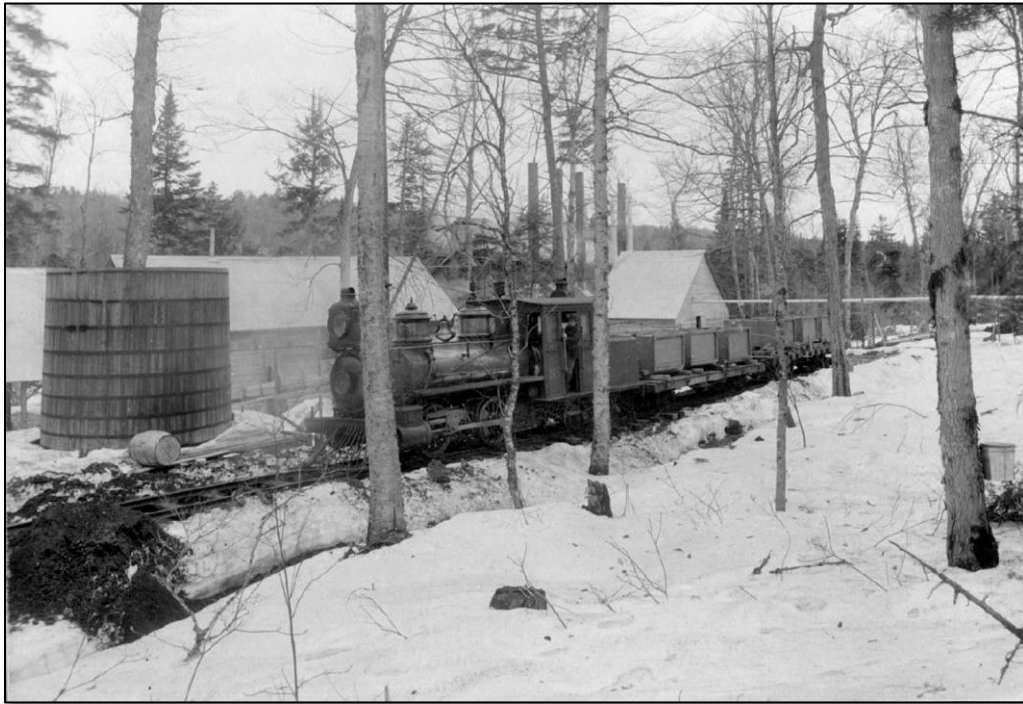
Figure 7.6: Baldwin image showing Locomotive No. 4 on the narrow-gauge railroad in front of the Wake Robin syrup plant. Collections of the Adirondack Experience P011350.

colored in the Baldwin album (see Chapter Five), and was submitted with the Library of Congress copyright series, includes the caption “Wake Robin Sugar House.” The second, non-colored image, omitted from the “Baldwin album” and copyright application, was found in the collections at the Adirondack Experience with a caption of “Locomotive ‘no.4’ making delivery of sap from tanks on two flat cars at Wake Robin Evaporator.”(Figure 7.6)

In the foreground of the image in Figure 7.6 is the east-west running narrow-gauge Wake Robin Railroad track with the locomotive “No. 4” pulling two flatbed cars, each carrying three large sap gathering tanks. A close examination of the area behind the last flatbed car in the photo shows that this was the terminus of the railroad track. In fact, one can see in both photos that the sap pipeline running downhill and into the sap storage building was placed just beyond the end of the tracks. Placing the end of the Wake Robin track at this point is consistent with how the grade was mapped in both the 1907 USGS Tupper Lake map and the 1913 Conners and Sewall map. Figure 7.6 shows a large wood stave tank alongside the railroad grade. This tank may have contained water for the steam locomotive, or it may have been used for sap storage for the syrup operation.

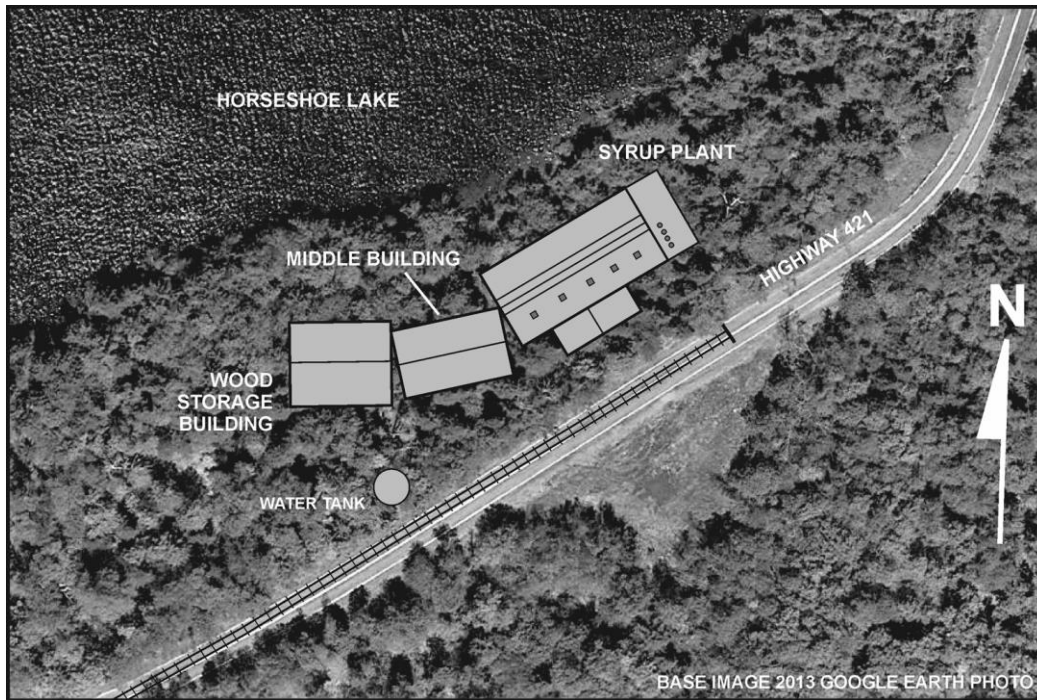
Figure 7.7: Schematic drawing of the layout of the buildings at the Wake Robin syrup plant in relation to modern features alongside State Highway 421 and Horseshoe Lake.

The design and layout of the Wake Robin syrup plant, with multiple smaller buildings of different shapes, orientations, and profiles, suggest that this syrup plant may have developed and expanded over time, rather than having been planned as a tight purpose-built structure, like we see at Maple Valley. This further suggests that this syrup plant at Wake Robin predates the Maple Valley design, with Wake Robin evolving more organically. Based on the combination of archival and field investigations, Figure 7.7 depicts a schematic interpretation of the layout of the Wake Robin syrup plant site during its period of use. A modern aerial photograph serves as a base layer to show the current

location of State Highway 421, the borrow/work area, the lake, and modern vegetation as well as the linear nature of the layout of the syrup plant buildings.

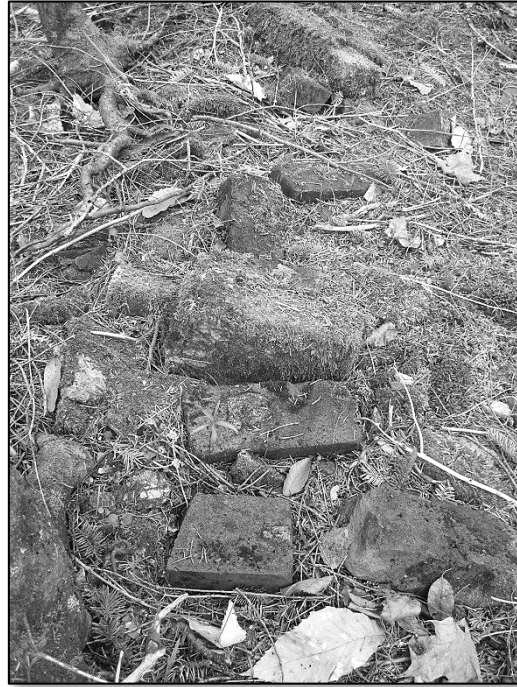
Figure 7.9: Example of bricks from the remains of a fallen support pier at the Wake Robin syrup plant. Photo by author.

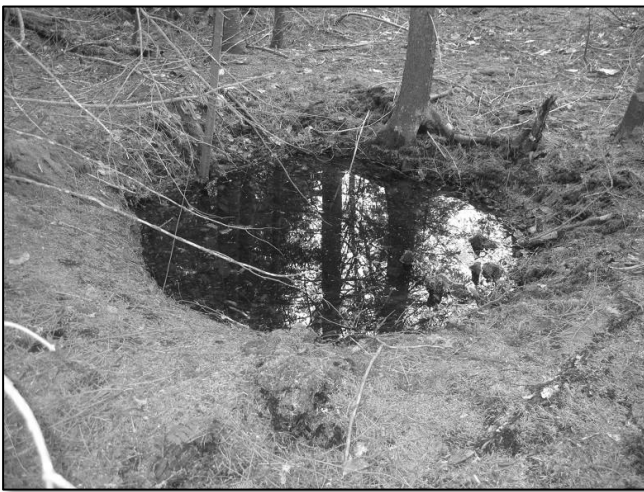
Figure 7.10: Example of water filled depression at site of Wake Robin syrup plant. Photo by author.

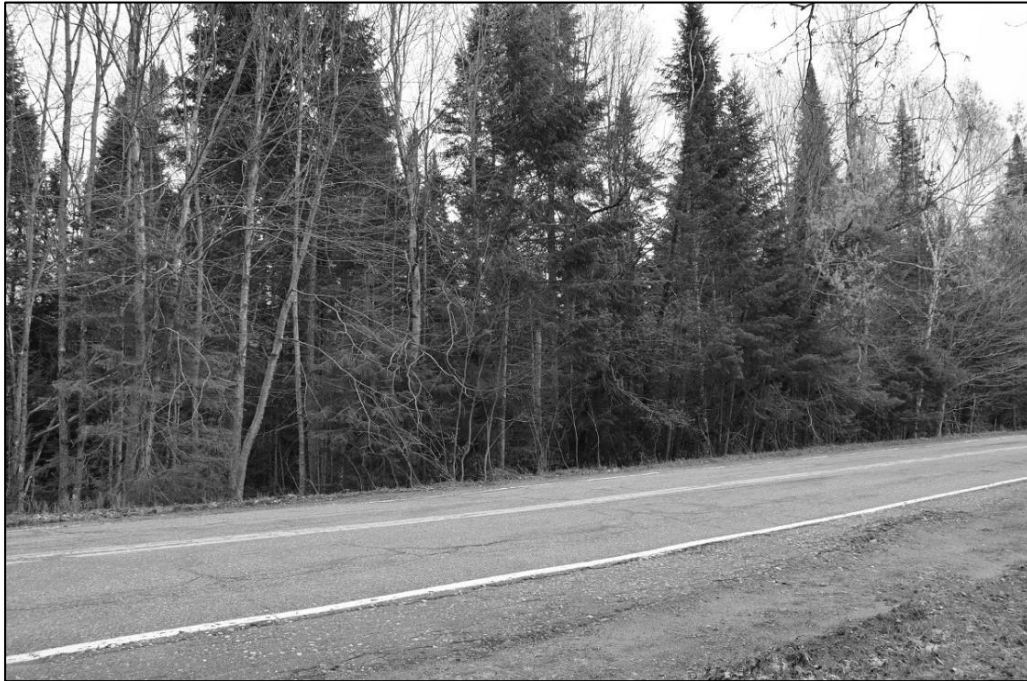
Figure 7.11: Image of what the area of the Wake Robin syrup plant looks like today. Compare the scene in this image to that of Figure 7.6. Photo by author.

ground and aerial photos of this location indicate that the area where we would expect the syrup plant to have stood is marked by a clustering of a tangled growth of 50 to 60-year-old spruce and young balsam trees. That a dense growth of spruce and balsam would be present is consistent with this space having recently been an opening in the forest with disturbed ground.
